Mosquito Creek Ravine East Bank Assessment

City of North Vancouver
141 14th Street
North Vancouver
B.C. V7M 1H9

Wednesday, July 19, 2006
Project #: 005-051

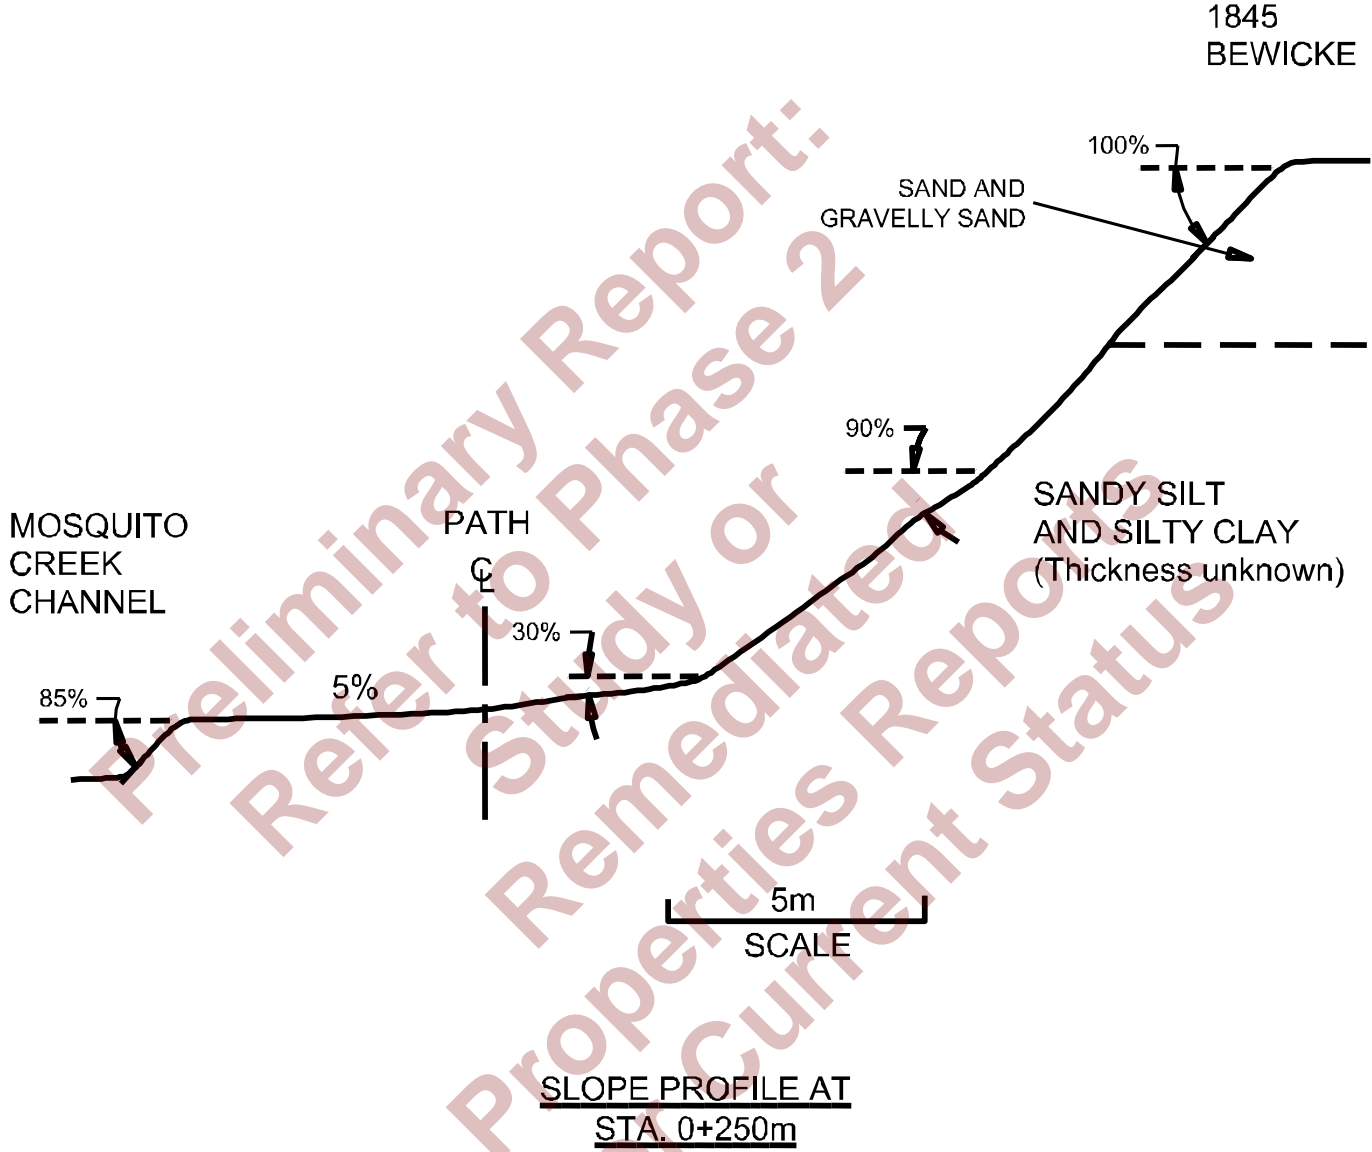
CITY OF NORTH VANCOUVER		EAST BANK ASSESSMENT			
MOSQUITO CREEK		SLOPE PROFILE, Sta. 0+250, TH05-1			
PROJECT NO.	DATE	ISSUE	BY	DATE	PAGE NO.
005-051	PTS	TS	TS	18/07/05	AS NOTED 2

In TH05-1, the sandy silt was found below 3.0 m depth while the silty clay begins at 6.7 m depth. Refusal was encountered at 8.8 m depth, likely in very dense till or till-like material. The groundwater level measured in the piezometer was at 3.7 m depth within the sandy silt.
