Drinking Water Quality – 2022 Annual Report

JANUARY 2023 | ENGINEERING, PARKS AND ENVIRONMENT

PREPARED BY LUKE GILLIES, MEM, P.ENG., C.I.M., SECTON MANAGER, UTILITIES

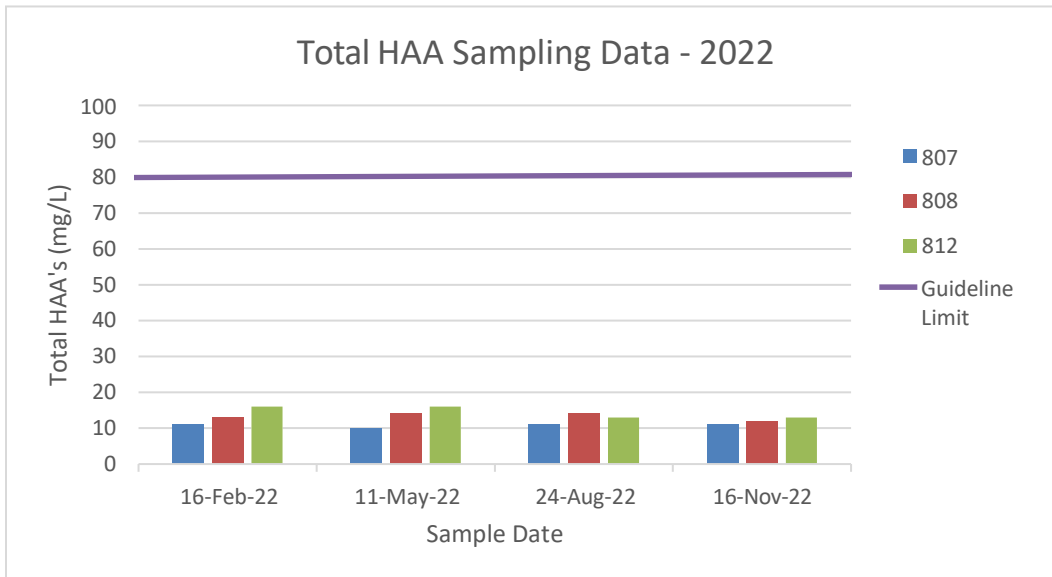
The following figure plots total HAA by period and sampling station, where total HAA was typically slightly higher at sampling station 812 (539 East 20th). There is otherwise very little variation in the results and total HAA concentrations are substantially lower than the allowable guideline value.

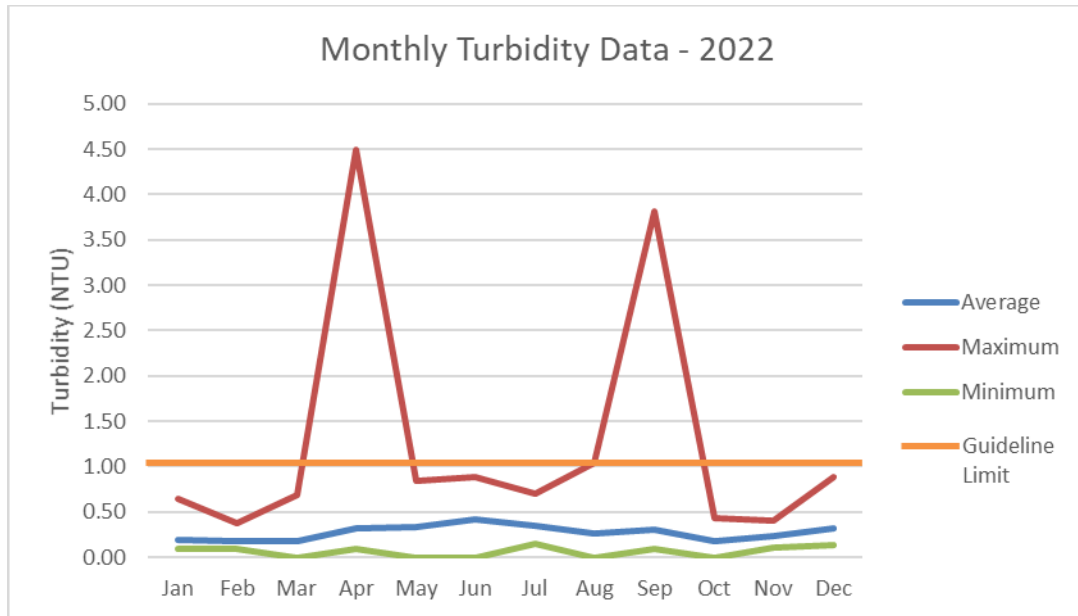
The figures above summarize the turbidity data by station and by month. Appendix B provides a description of the sampling parameters, the allowable limits, and a detailed summary of the 2022 test results.

In 2022 a total of 4 samples exceeded the recommended turbidity level of 1.0 NTU, for a total of 0.77% of the 517 samples, which is considered very low given the large percentage of cast iron water mains in the utility. These four instances of exceedance occurred at four separate stations throughout the City. Given that, none of these sites are considered to be chronic problems, and are likely due to a local disturbance of settled sediment or iron precipitate in the water main.
